European Federation of
Corrosion Publications
Number 50

Corrosion behaviour and protection of copper and aluminium alloys in seawater

Edited by D. Féron

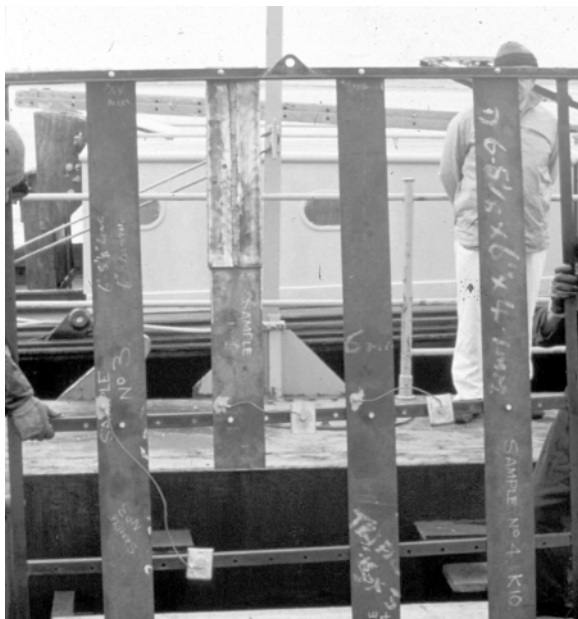
5.3 Cathodically protected steel, CuNi90/10 partially sheathed steel and CuNi 90/10 panels and a freely exposed copper nickel panel prior to immersion from a raft, UK.

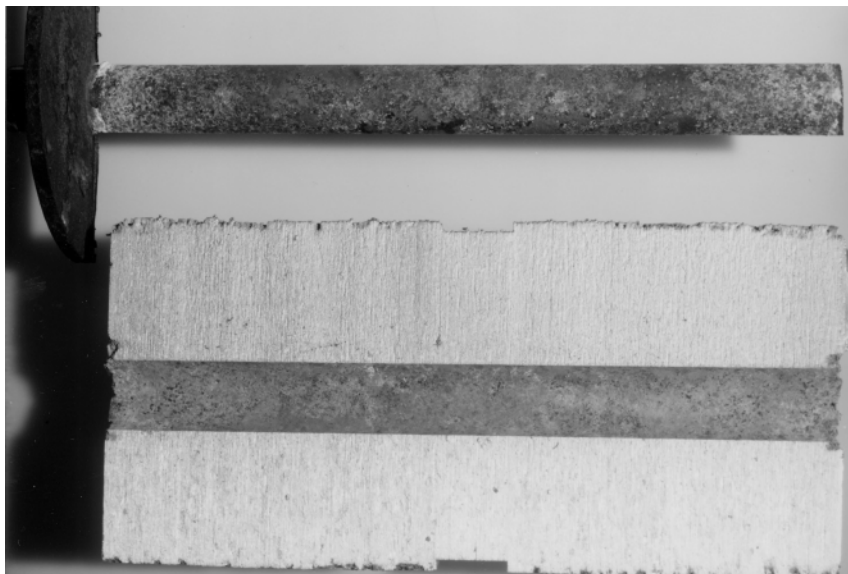
11.2 Decohesion and corrosion between anode and insert after four months of operation.

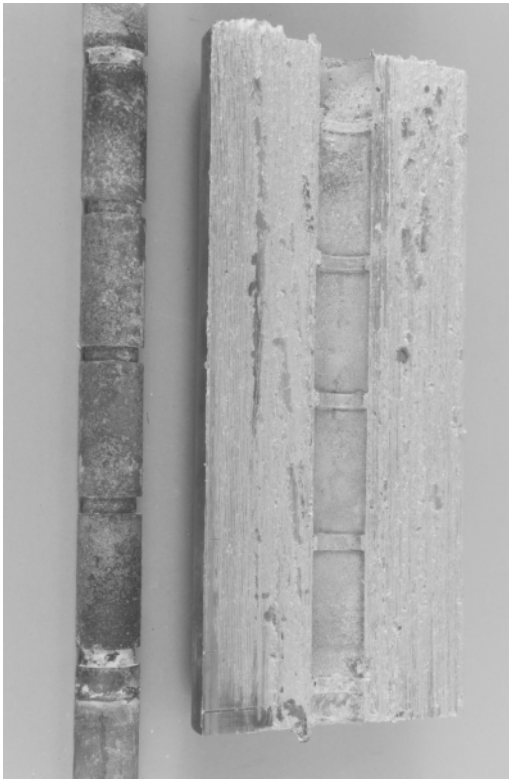
11.14 Plain steel insert with regular throttling after pressure testing.
